11. TITLE (Include Security Classification) Corrosion Phenomena During Overcharge in Polymer Electrolyte Cells					
12. PERSONAL AUTHOR(S) M.Z.A. Munshi, R. Gopaliengar, & B.B. Owens					
13a. TYPE OF REPORT Technical		13b. TIME COVERED FROM 7/15/85 TO 5/30/88		14. DATE OF REPORT (Year, Month, Day) May 1988

Corrosion Phenomena During Overcharge
in Polymer Electrolyte Cells

M.Z.A. Munshi
R. Gopaliengar
B.B. Owens

Department of Chemical Engineering and Material Science
Corrosion Research Center
University of Minnesota
221 Church St. SE
Minneapolis, MN 55455
USA

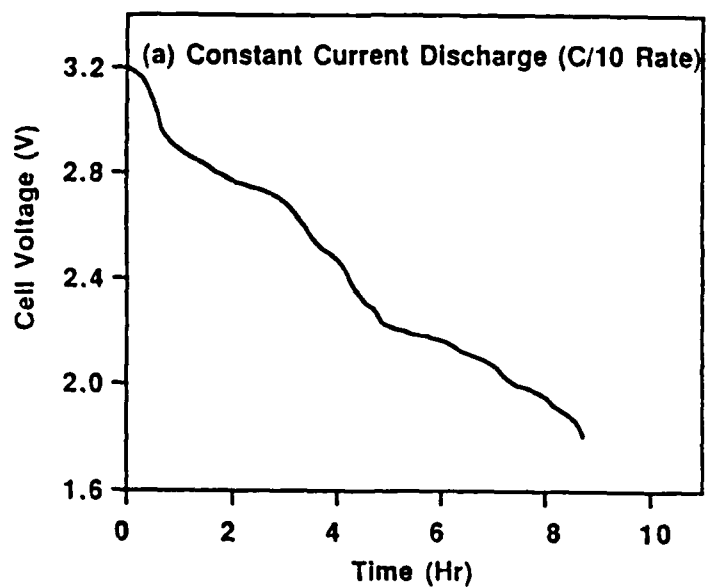
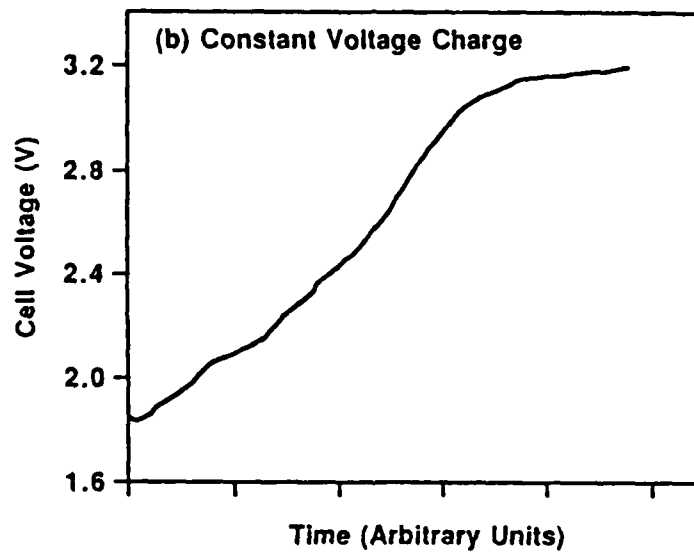
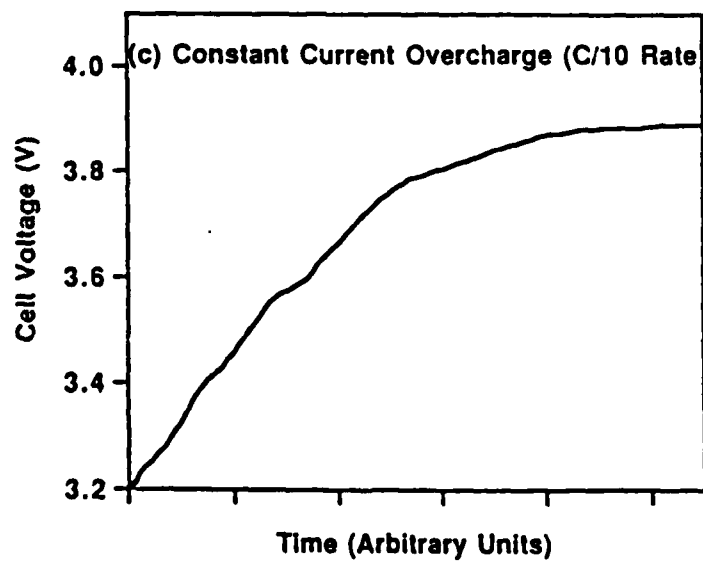
Figure 1 shows the cycling sequences for the polymer electrolyte cells. Figure 1a depicts a typical constant current discharge followed by a typical constant voltage charge (Figure 1b) through a current limiting resistor. The constant potential is maintained across the fixed resistor and the cell such that as the cell charges, the voltage drop across it increases with a corresponding decrease across the fixed resistor. The current flowing through the cell decreases until the cell is fully charged. Once the cell has attained stabilization in capacity with cycle number and the coulombic efficiency in the final charging cycle has reached close to 100%, the cell is placed on overcharge at the C/10 rate. A voltage-time profile for cell #1 utilizing a thin cathode is shown in Figure 1c. In this case the cell stabilizes at 3.9V . The behavior appears to be quite different from cells utilizing thick cathodes [7] where the cell reached about $+5\text{V}$, sufficient to decompose the electrolyte.

Figure 1. Cycling profiles for the polymer electrolyte cells.
